Thule Air Base Airfield White Painting and Permafrost Investigation

Phases I–IV

June 2013

Final report

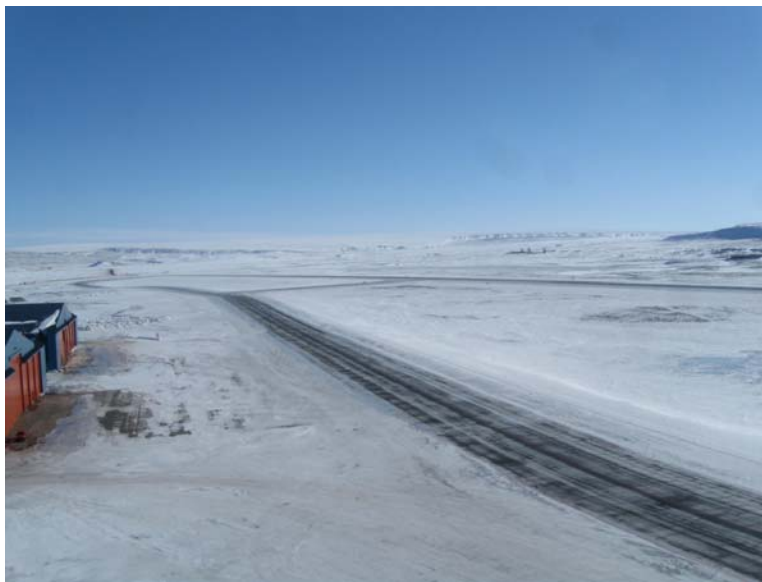
Figure 15. View from the tower April 2011, looking east to the 26 end of the runway. The faded and dark nature of the paint is very evident against the backdrop of white snow.

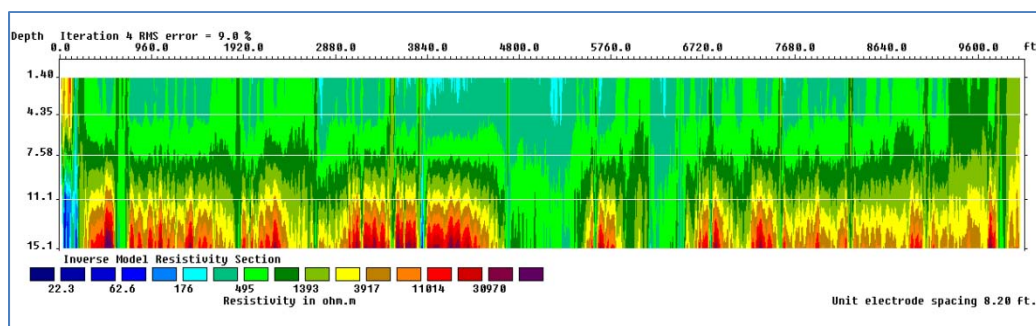
Figure 42. Runway resistivity cross-section from 00+00 to 100+00. The locations of the pre-construction surface drainage feature at ~52+00, and the location of the existing depressions at 62+00 are visible in blue with the lower resistivity (high conductivity). The undulating frozen ground boundary is also clearly defined by the yellow and red shading. (Depth scale is exaggerated in this figure.)
